Mitsui Chemicals Iwakuni-Ohtake Works
Resorcinol Plant
Accident Investigation Committee Report

January 23, 2013

Resorcinol Plant Accident Investigation Committee
Mitsui Chemicals Iwakuni-Ohtake Works

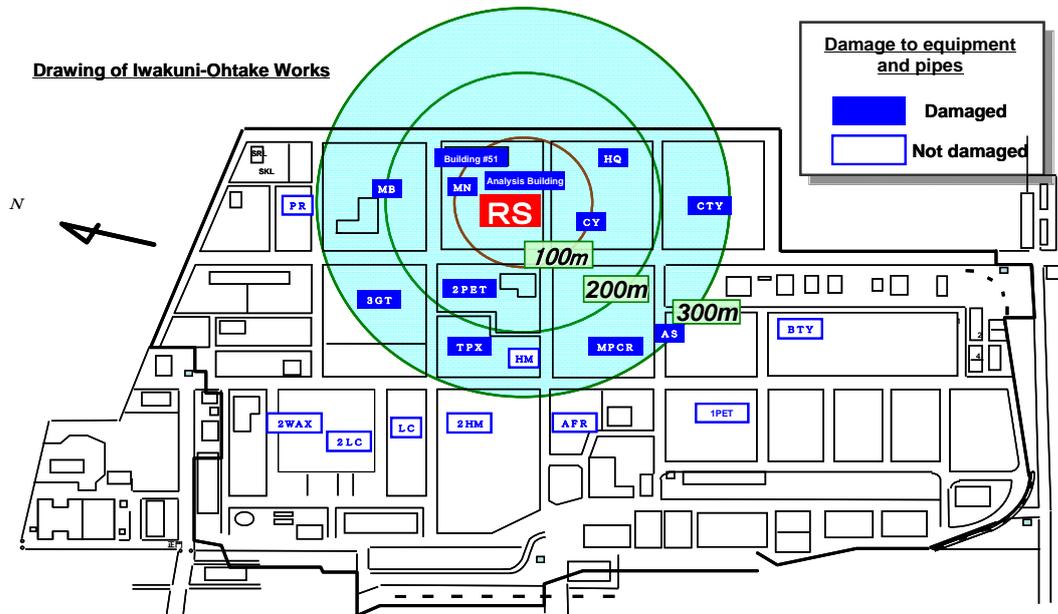
Figure 2-2 Damage within plant premises

Damage to equipment and pipes were found in a 300m radius around the resorcinol plant. (Refer to Fig. 2-2)

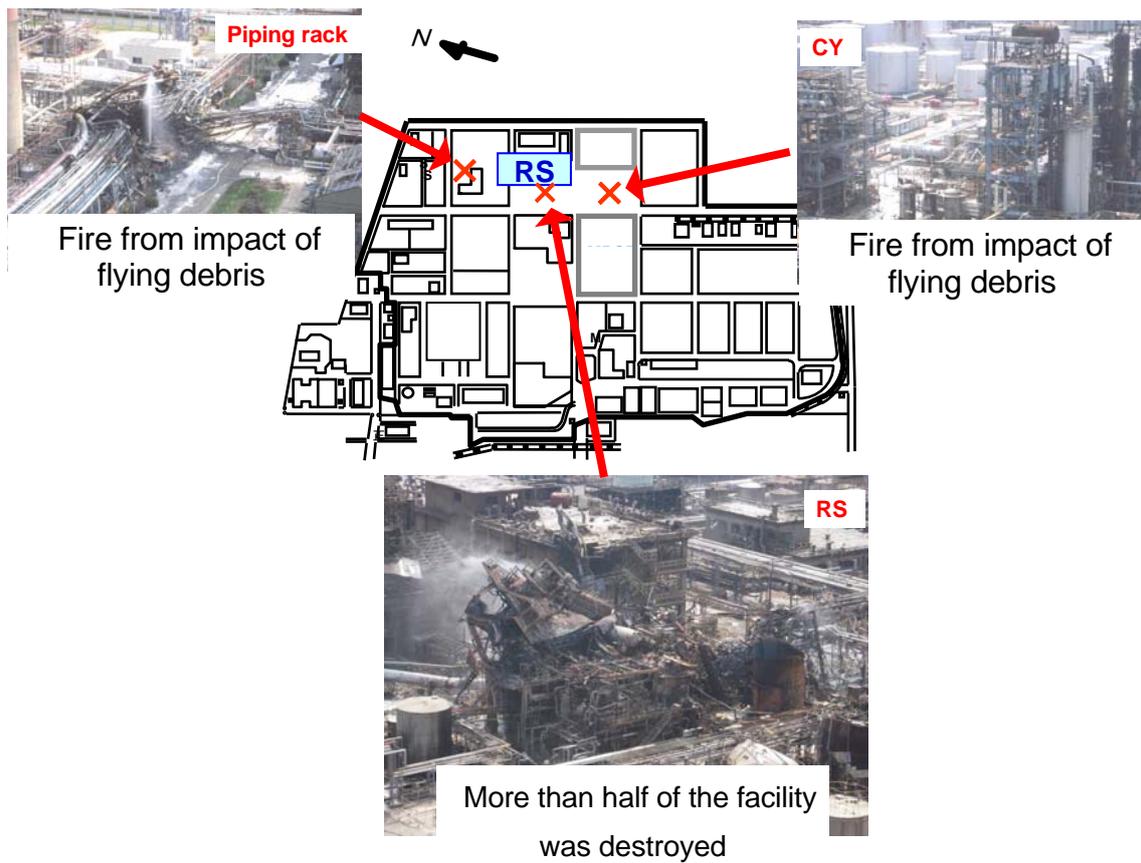
Figure 2-3 Damage to area surrounding the resorcinol plant

Fig. 2-3 shows an enlargement of the location where the fire occurred. More than half of the resorcinol plant was destroyed. At the cymene plant and the utilities piping rack, large broken pieces of the resorcinol oxidation reactor were discovered where the fire started, and there was damage from the impact of the flying debris.

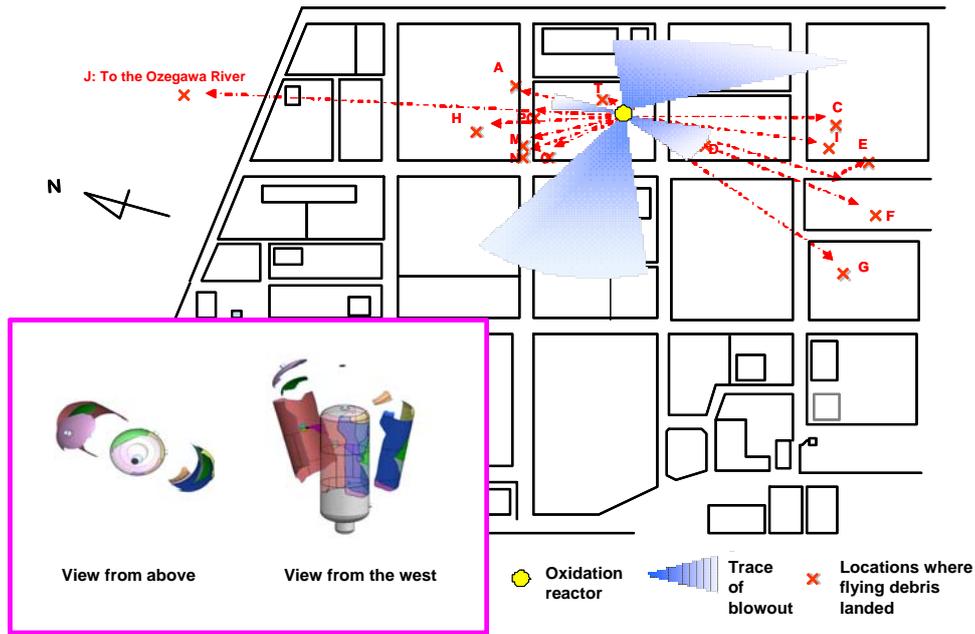
Figure 2-4 Scattering of the Oxidation Reactor

The upper part of the oxidation reactor had broken into pieces and was scattered in the explosion, leaving only the skirt and the lower part of the main body (Fig. 2-4). The scattered pieces were distributed to the north (Hiroshima side) and south (Iwakuni side) of the location where the oxidation reactor was installed. The contents of the reactor were scattered to the east and west.

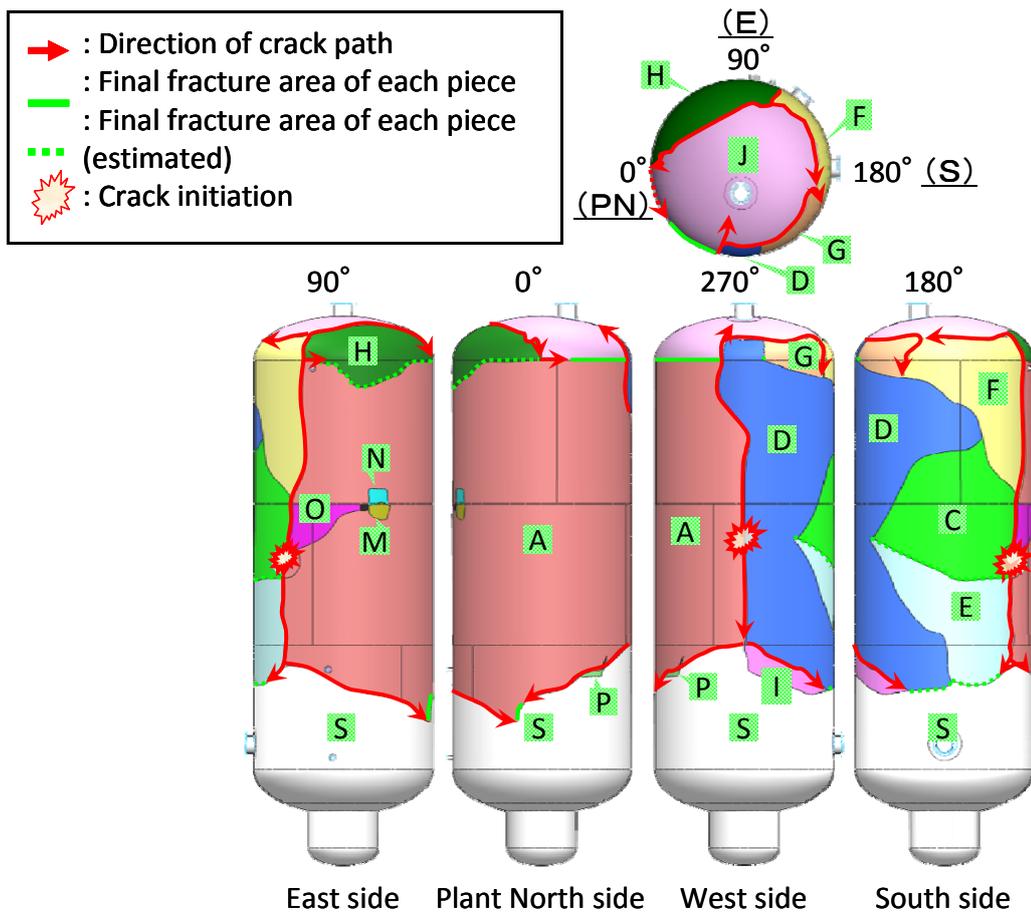
Figure 2-5 Crack initiation and crack paths

Figure 2-5 shows the estimated crack initiation and crack paths based on a visual observation of the fracture surface. It was estimated that the initiation was at the manhole which was a discontinuous part of the structure located near the 120° radius direction and at the insulation rib located near the 270° radius direction.

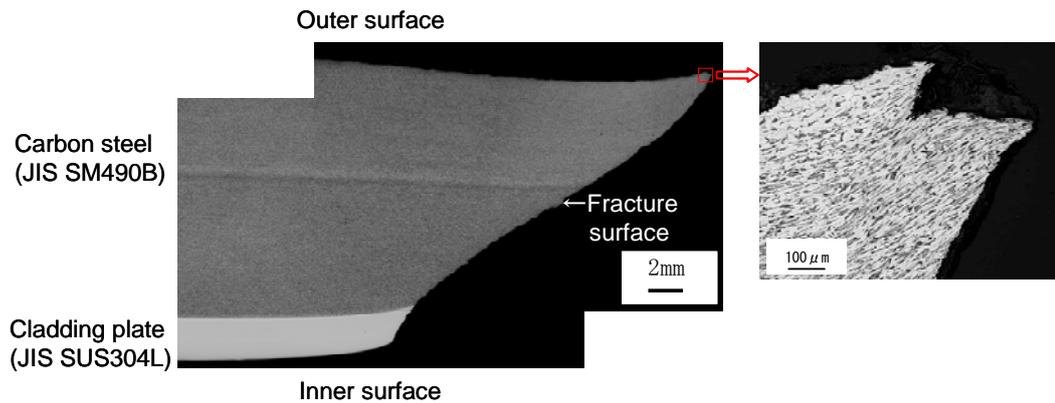
Figure 2-6 Observation of texture of fracture surface

Reduction in thickness and elongation of the microstructure from plastic deformation due to the rise in internal pressure were observed and dimples, a characteristic feature of ductile ruptures, were confirmed on all of the fracture surfaces of the initiation, crack paths and final fractured parts.

Figure 2-6 shows the cross section of the fracture surface of the reactor near the manhole that is thought to be the initiation point on the 120° radius direction (Piece C) and Figure 2-7 shows the dimple fracture surface observed on the same piece in Figure 2-6.

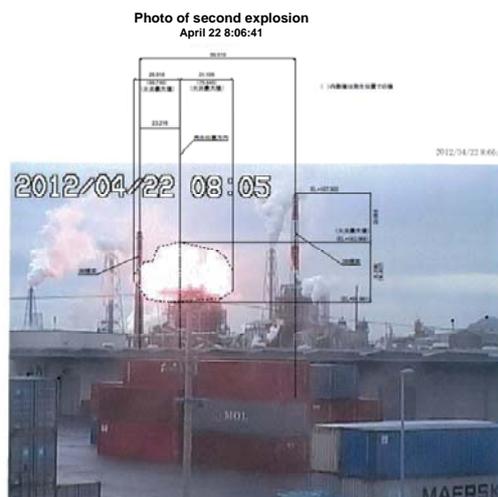
Figure 2-8 Image of the second explosion

Based on these observations, it is thought that after the first explosion, the oxidation reactor was not cooled sufficiently and since there continued to be small fires in the surrounding area, the reactor was heated. The heating caused the temperature of the hydroperoxide (HPO) remaining at the bottom of the reactor to rise and accelerated self-decomposition causing large quantities of flammable gas to burst out. The flammable gas and the residual liquid (mist) in the reactor were scattered and ignited to create a fire ball as shown in Figure 2-8.

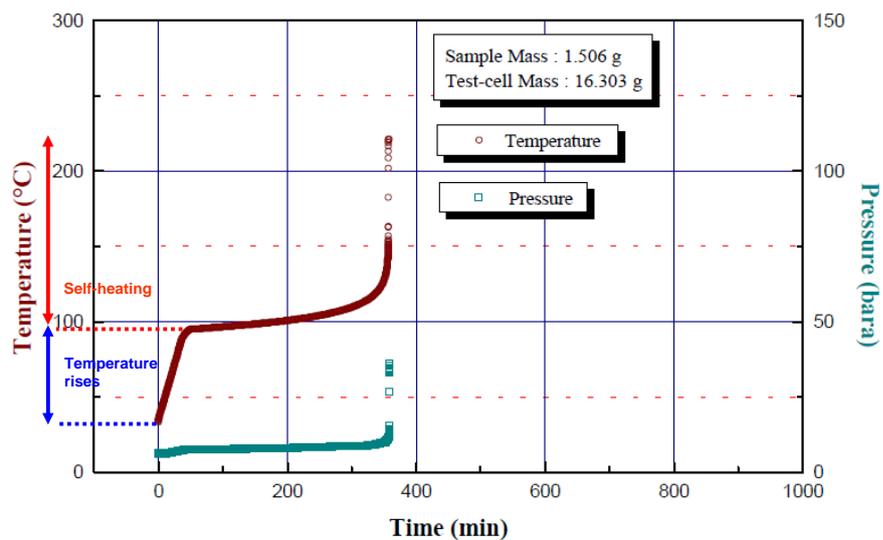
Figure 4-6 Arc measurement results of the oil layer of the small test mixture (after pre-treatment) (Actual measured values)

The results of the ARC measurement are as shown in Figure 4-6 and it was confirmed that in an adiabatic condition, when the temperature rises, self-heating is pronounced and both the temperature and pressure rise suddenly.

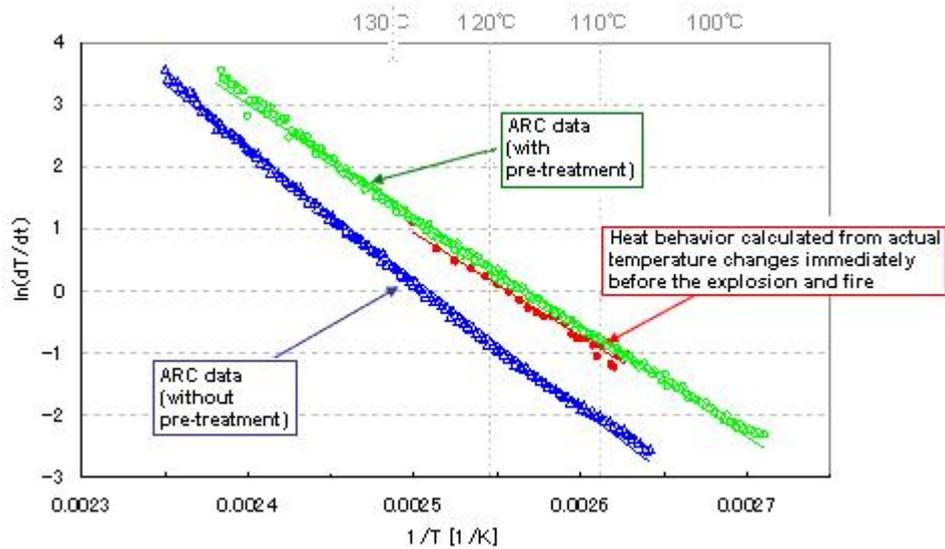
Figure 4-7 Results of ARC analysis of oil layer of the small test solution (with and without pre-treatment) and changes in temperature when the explosion and fire occurred (The unit for dT/dt is [K/min]. Adjusted for specific heat)

Next, an Arrhenius plot was used to organize the ARC measurement data and as you can see in behavior of the solutions “with pre-treatment” in Figures 4-7 and 4-8, the changes in temperature were similar to when the explosion and fire occurred with the actual equipment. Therefore, it is assumed that the rise in temperature in the upper liquid phase where there was no cooling coil occurred due to heat decomposition of the HPO under these conditions.

It should be noted that there was a difference in the heating speed when no pre-treatment was conducted, as shown in Figure 4-7.

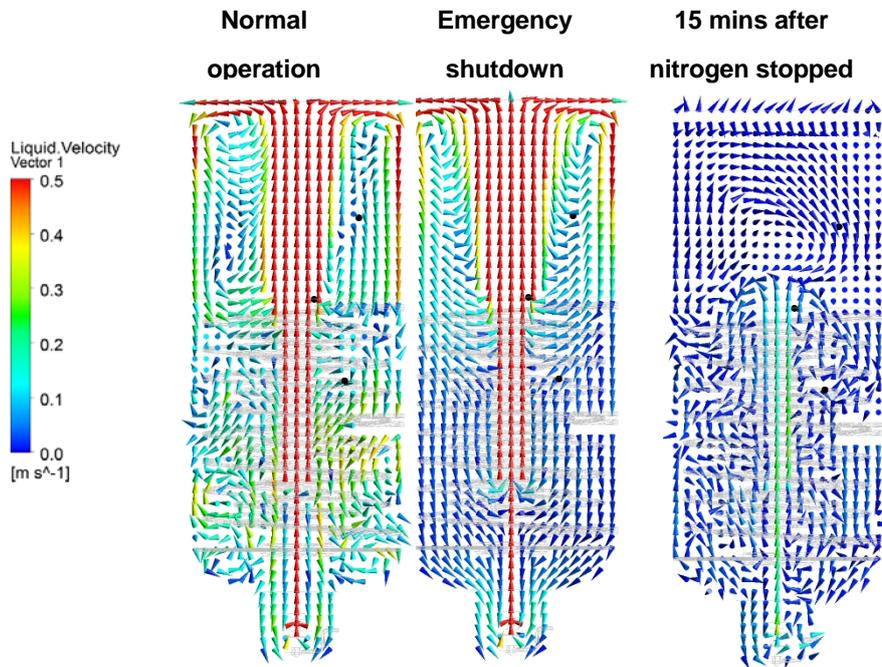
Figure 4-9 Changes in the liquid velocity vector

As a result of analyzing the flow conditions after the nitrogen supply for agitation was stopped, it was determined that as time passed, the liquid flow throughout the reactor dropped and 15 minutes after the nitrogen supply was

stopped, only a slight upward flow in the draft tube and some flow around the coil could be seen, and the liquid around the upper liquid phase where there was no cooling coil was almost completely still and no liquid was exchanged with the lower liquid phase (Refer to Figure 4-9).

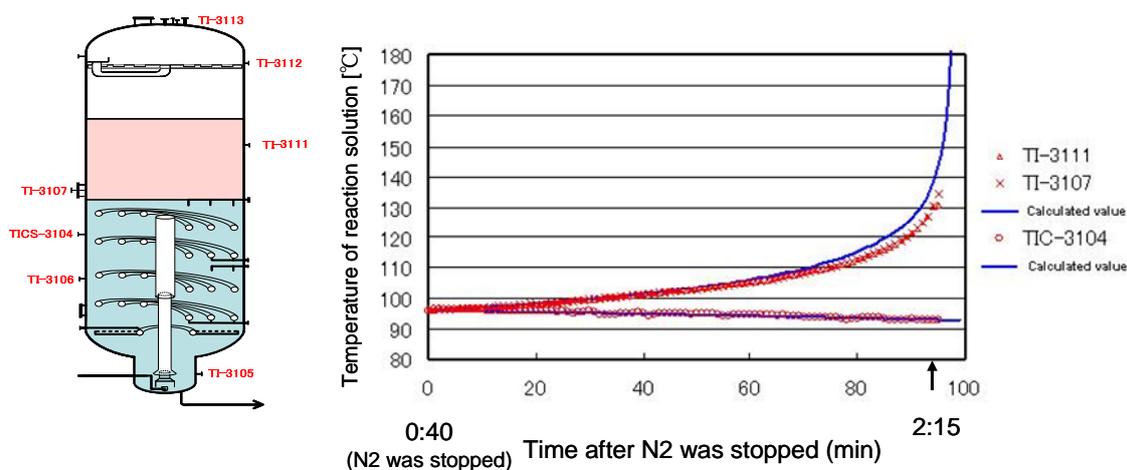
Figure 4-10 Changes in temperature in the oxidation reactor after the nitrogen supply is stopped and results of calculation

Additionally, verification was made of the changes in temperature in the upper and lower liquid phases after the nitrogen supply was stopped. The initial temperature of the liquid was set at 96°C and it was assumed from the flow conditions that there was no exchange of liquids between the upper and lower liquid phases. The changes in temperature at each point were calculated based on the heat balance of the HPO decomposition heat and the heat removal from the cooling coils. As a result, the calculated value of the temperature of the oxidation reactor showed similar trends as the actual temperatures recorded the day of the accident (Refer to Figure 4-10). Based on this, it is thought that the temperature in the lower liquid phase dropped gradually as it was cooled and the temperature rose in the upper liquid phase due to the decomposition reaction of the HPO.

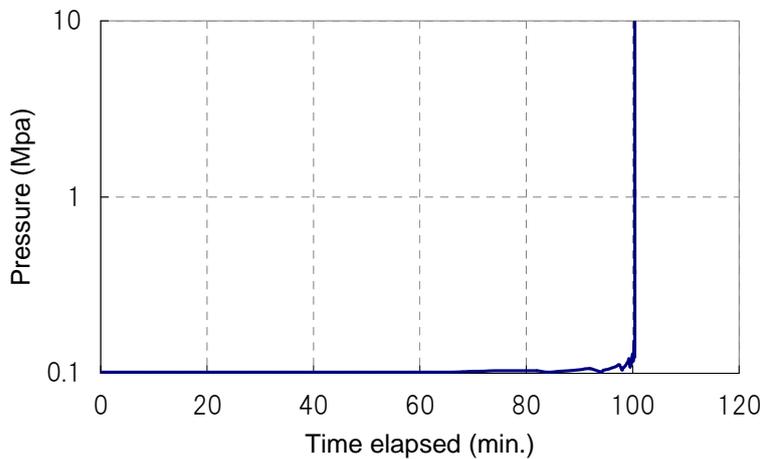
Figure 4-13 Estimated change in pressure over time

By solving the two equations as a system of equations, the changes in the temperature, speed of gas generation and pressure over time after the nitrogen supply for agitation was stopped could be estimated as shown in Figure 4-13 and the results showed that the pressure would eventually exceed 10 MPa.

Additionally, the internal pressure when the oxidation reactor burst was estimated to be 8 MPa or higher from the elasto-plastic analysis using FEM and the rupture stress of the manhole bolt, and combining that with the results of the calculations above, it is assumed that the rise in pressure from the gas generated caused the reactor to burst.
