### **Explosion and Fire at Iwakuni-Otake Works (#11)**

Report on the Investigation of the Explosion and Fire Serious Incident at  
Resorcinol Production Facility at Iwakuni-Otake Works (Summary)

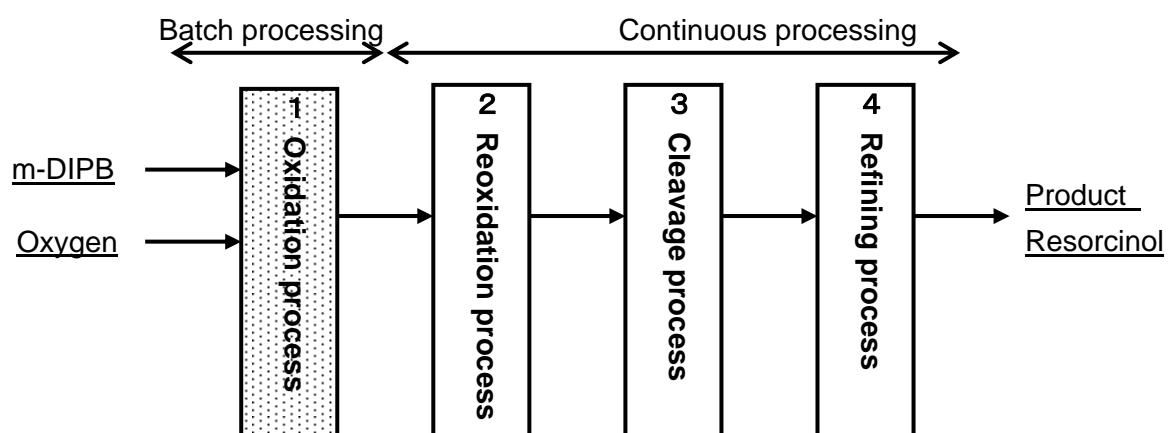
- The plant started operations in 1980 and the oxidation reactor was installed in 1999.
- Production capability is 7,600 tons annually.
- The main processes of the facility are 1) oxidation, 2) reoxidation, 3) cleavage, and 4) refining processes.

Figure 1. Block flow of the resorcinol production process

- 1) Oxidation process: The raw material meta-Diisopropylbenzene (hereinafter referred to as m-DIPB) is oxidized with oxygen in the air to create an intermediate.  
 $m\text{-DIPB} + \text{oxygen} \rightarrow \text{Dihydroxy peroxide}$  (hereinafter referred to as DHP)  
+ Hydroxy hydroperoxide (hereinafter referred to as HHP)
- 2) Reoxidation process: HHP + oxygen  $\rightarrow$  DHP
- 3) Cleavage process: DHP  $\rightarrow$  Resorcinol + Acetone
- 4) Refining process: After removing impurities through separation by distillation and crystallization, flaking is conducted to create products.

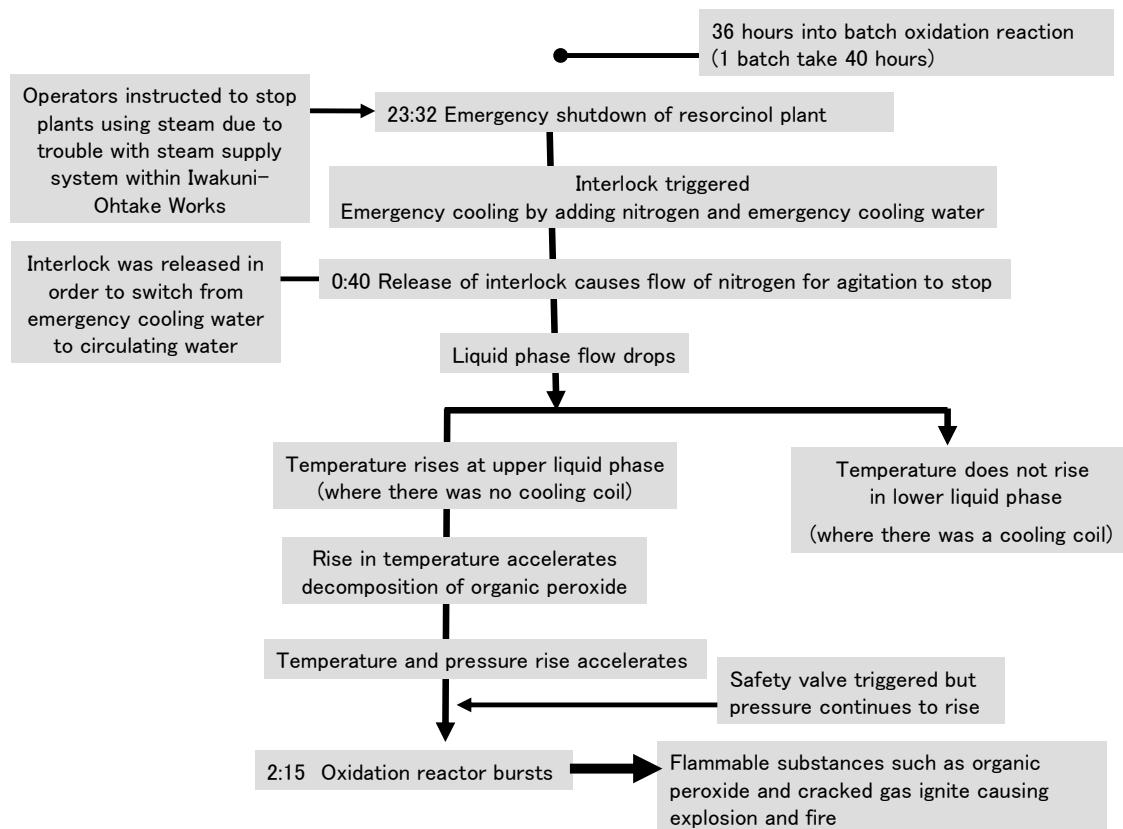
- As for the events leading up to the accident, based on operation data (DCS data), testimonies from operators, thermal behavior measurements using adiabatic calorimeters (ARC test devices), and analysis of flow simulation, we have estimated the following.

Figure 2. Events leading up to explosion and fire

- The following events leading up to the accident have been summarized in two parts. The first starts with the emergency shutdown to release of the interlock. The second starts with the release of the interlock to the explosion and fire.

- With release of the interlock, the valve was automatically operated and nitrogen supply and agitation in the oxidation reactor was stopped. At the same time, cooling water was switched from emergency cooling water to circulating water.

- The upper liquid phase of the oxidation reactor did not have a cooling coil and decomposition heat from the organic peroxide could not be removed resulting in a gradual rise in temperature. (Temperature continued to drop for the lower liquid phase where there was a cooling coil.)

- Operators did not recognize the rise in temperature in the upper liquid phase. Organic peroxide continued to generate decomposition heat and temperatures continued to rise.

- At around 2:10, the decomposition reaction of the organic peroxide accelerated, temperatures rose and decomposition gas was also generated resulting in an increase in pressure.

- The safety valve was triggered but pressure continued to increase.
- At 2:15, the oxidation reactor burst, ignited, and exploded, causing a fire..

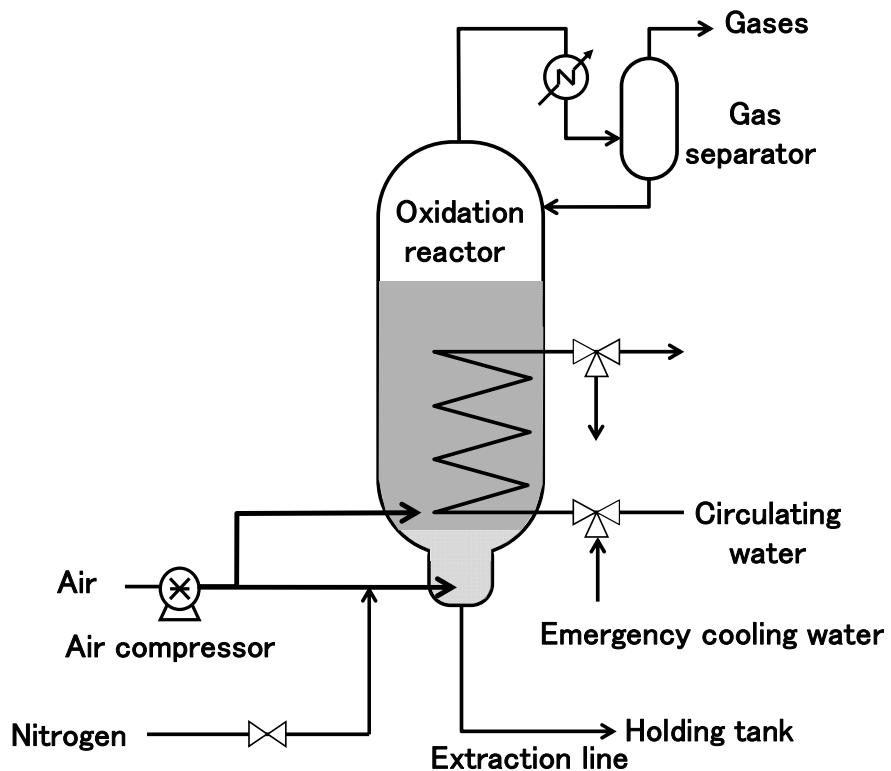
Figure 3. Flow sheet of resorcinol oxidation reactor

- The thermometer that triggers the interlock was only in the lower part of the oxidation reactor and not in the upper part.
  - <Regarding stopping agitation and delay in noticing temperature was rising>
