Mitsui Chemicals Iwakuni-Ohtake Works
Resorcinol Plant
Accident Investigation Committee Report

January 23, 2013

Resorcinol Plant Accident Investigation Committee
Mitsui Chemicals Iwakuni-Ohtake Works

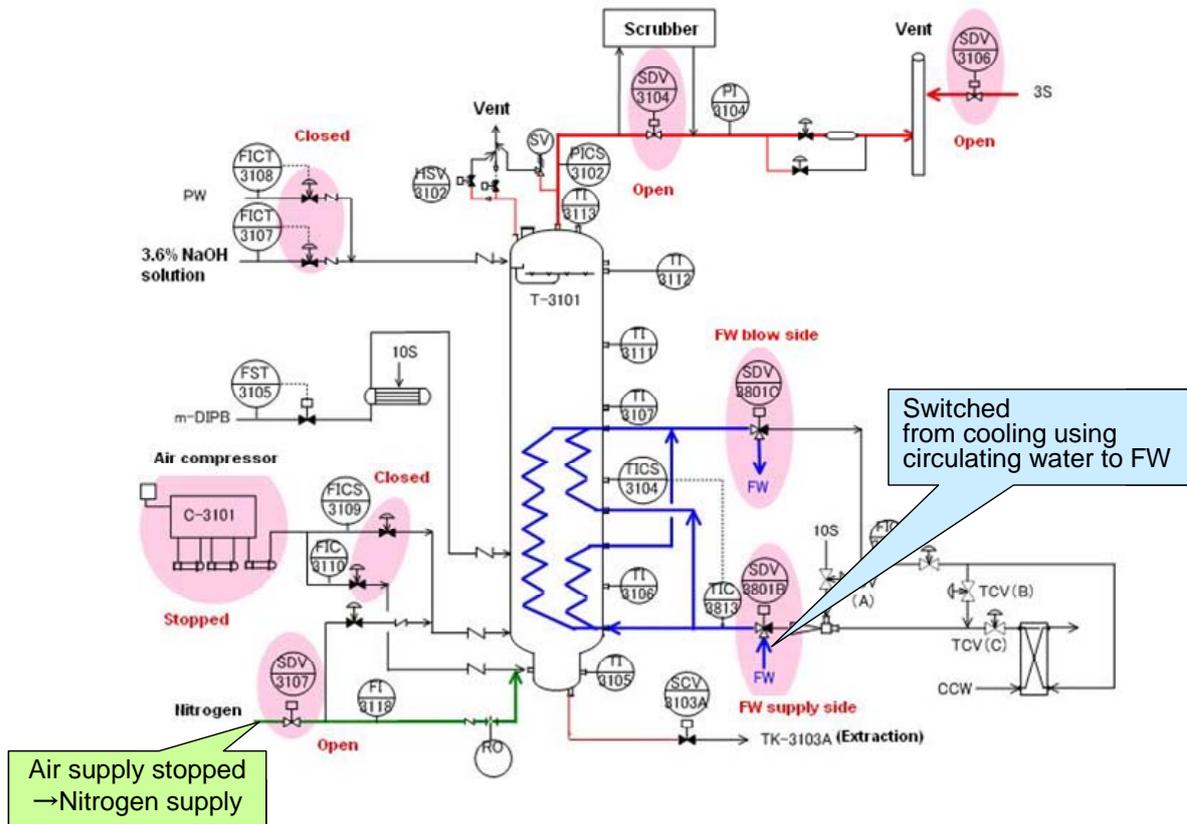
Figure 4-2 Flow during emergency shutdown (ESD) (When the interlock is activated)
(23:32 on April 21 to 0:40 on April 22)

- ~23:52
 - After the interlock was activated, since the temperature in the lower part of the liquid phase (TICS-3104, with cooling coil) did not drop, the operator checked onsite and found that the onsite pressure for FW was low at 0.3 to 0.4 MPaG. The FW pressure was low and the FW flow was insufficient so the operator thought the reactor temperature would not drop. He made a request to the utilities plant to raise the pressure of the FW and it was raised.

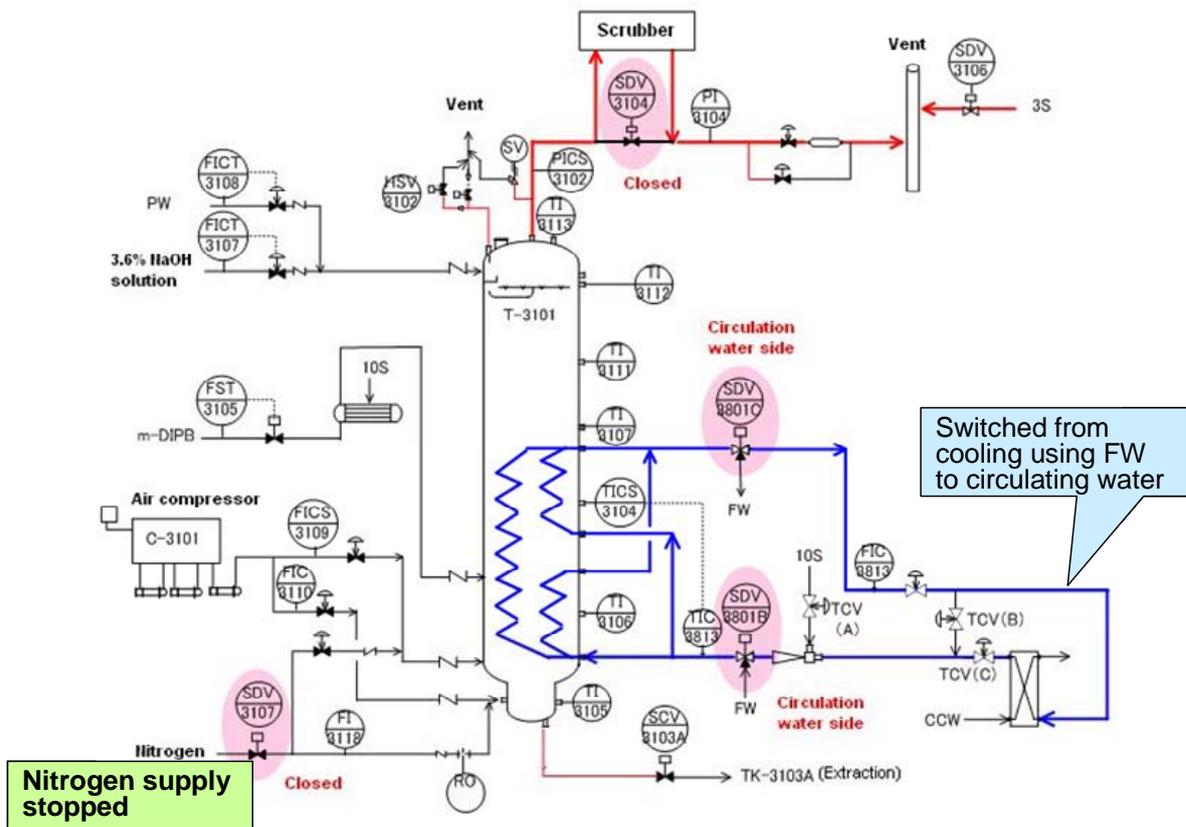
Figure 4-3 Flow for releasing interlock (0:40 to 2:15 on April 22)

(The operator was not aware at this time that the nitrogen supply had stopped.)

- 0:44~
- After the cooling water was switched from FW to circulating water, the temperature in the lower liquid phase (TICS-3104, with cooling coil) continued to drop. At the same time, because the nitrogen supply was stopped and agitation was stopped, the temperature in the upper liquid phase (TI-3107 and TI-3111, no cooling coil) which was the same as the lower liquid phase after the emergency shutdown, began to rise.

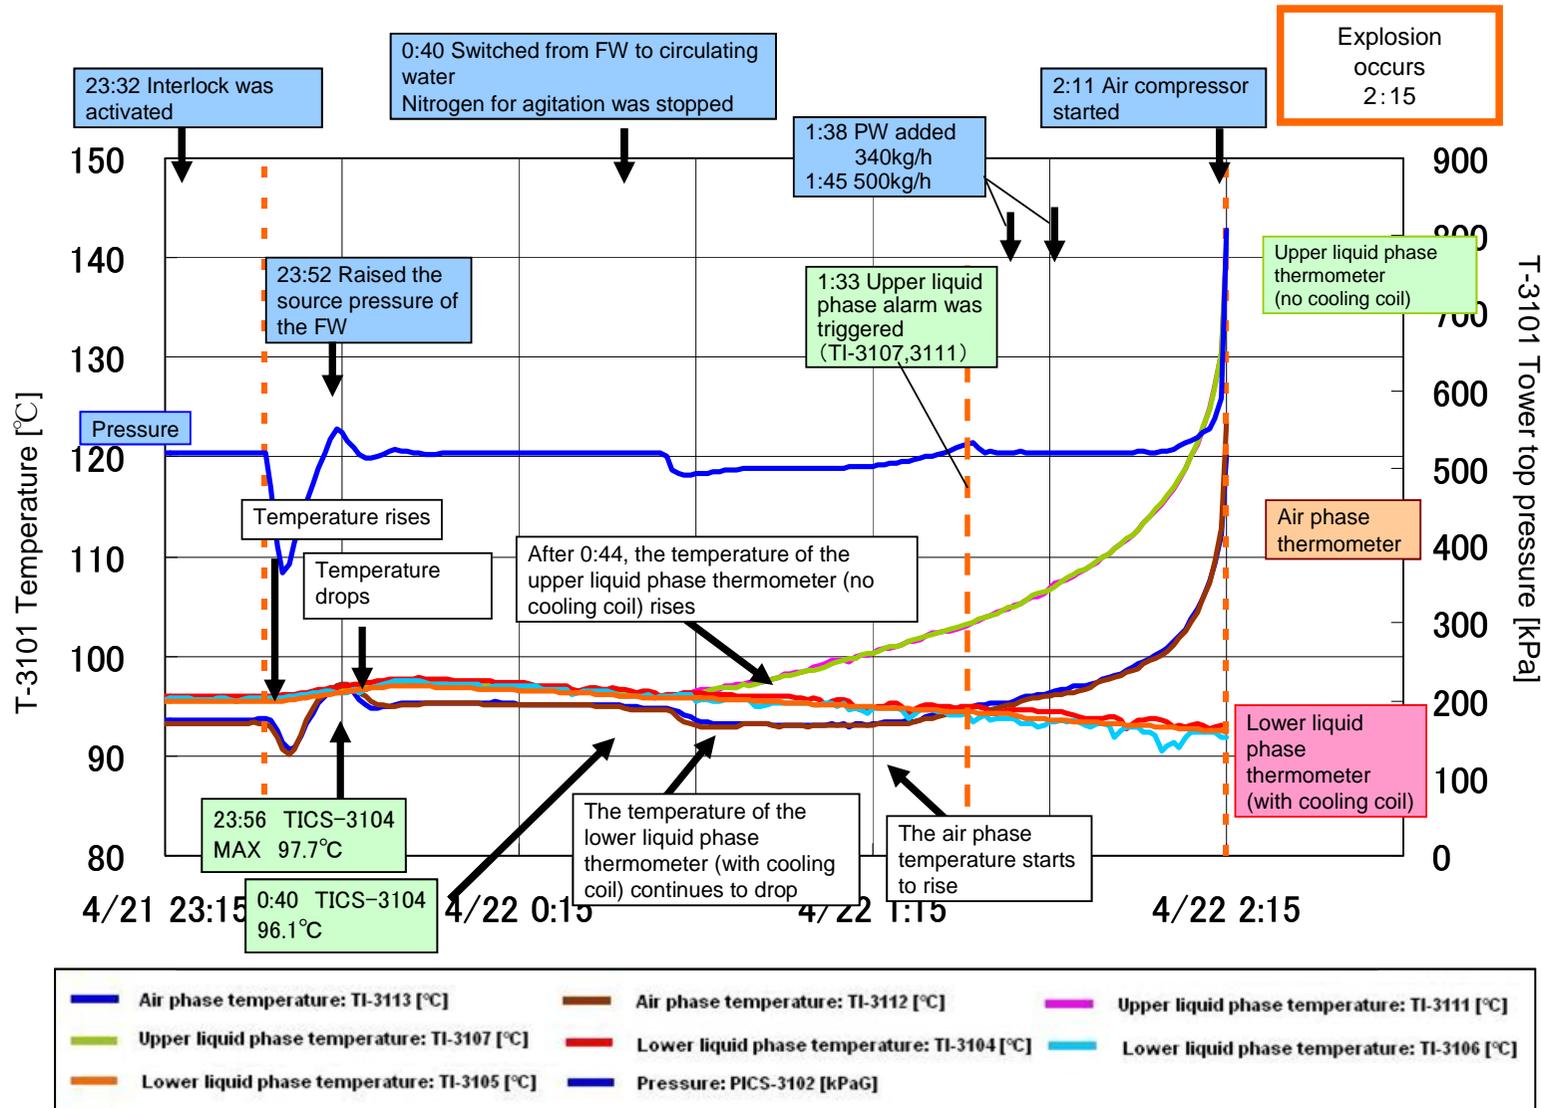
Figure 4-4 Operation condition up to the explosion and fire and temperature and pressure trends

- (Refer to Figure 4-4 Temperature trends)
- 1:33~1:38
- The temperature in the upper liquid phase (TI-3107 and TI-3111, no cooling coil) reached 104°C and the high-temperature alarm was triggered, but the operator thought that the temperature was rising in the gas phase and that the temperature was 96 to 97°C and within the range of normal operation. He thought that water would lower the temperature, so he began adding PW from the upper part of the reactor.

- (Refer to Figure 4-4 Pressure trends)
- 2:11~2:14
- The air compressor was started, and when the operator confirmed the pressure, he noticed that it had rose to 0.56 MPaG so he manually opened the pressure adjustment valve (PCV-3102) but the pressure could not be released in time and it continued to rise quickly.

- 2:15
- The pressure exceeded the design pressure of 0.8 MPaG causing the oxidation reactor burst and a fire was started.

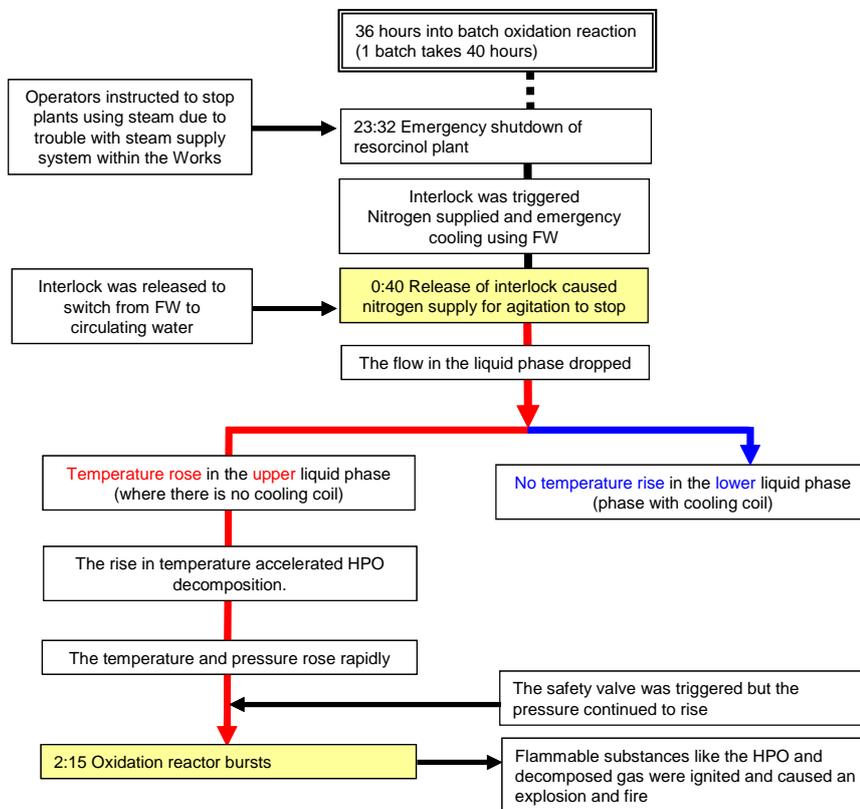
Figure 4-5 Flow of events leading up to the explosion and fire

Figure 4-5 shows the main points of the events that led to the accident in a time series.

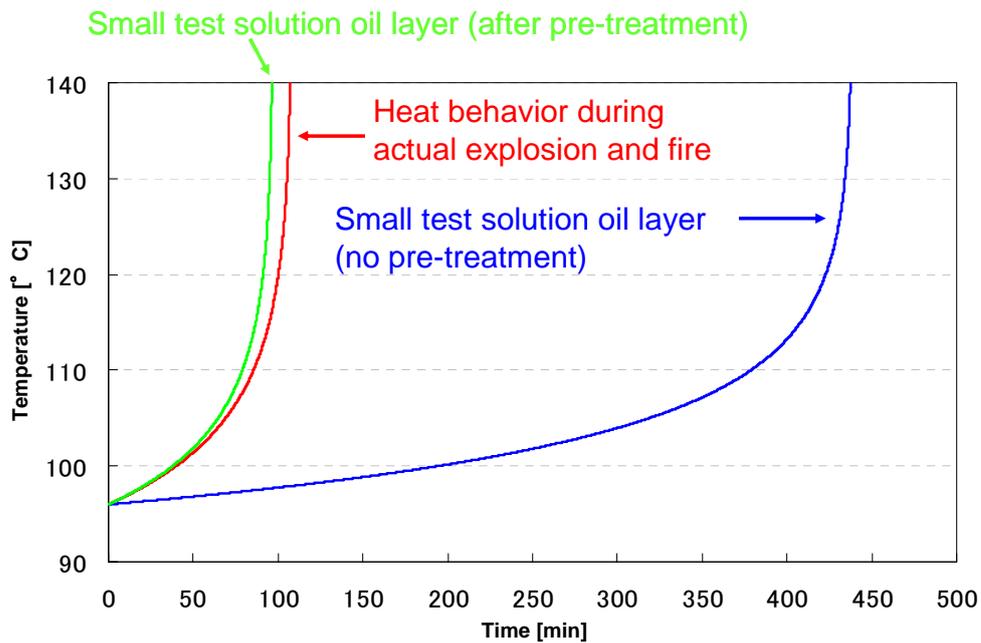
Figure 4-8 Changes in temperature (estimated from the Arrhenius formula)

Next, an Arrhenius plot was used to organize the ARC measurement data and as you can see in behavior of the solutions “with pre-treatment” in Figures 4-7 and 4-8, the changes in temperature were similar to when the explosion and fire occurred with the actual equipment. Therefore, it is assumed that the rise in temperature in the upper liquid phase where there was no cooling coil occurred due to heat decomposition of the HPO under these conditions.

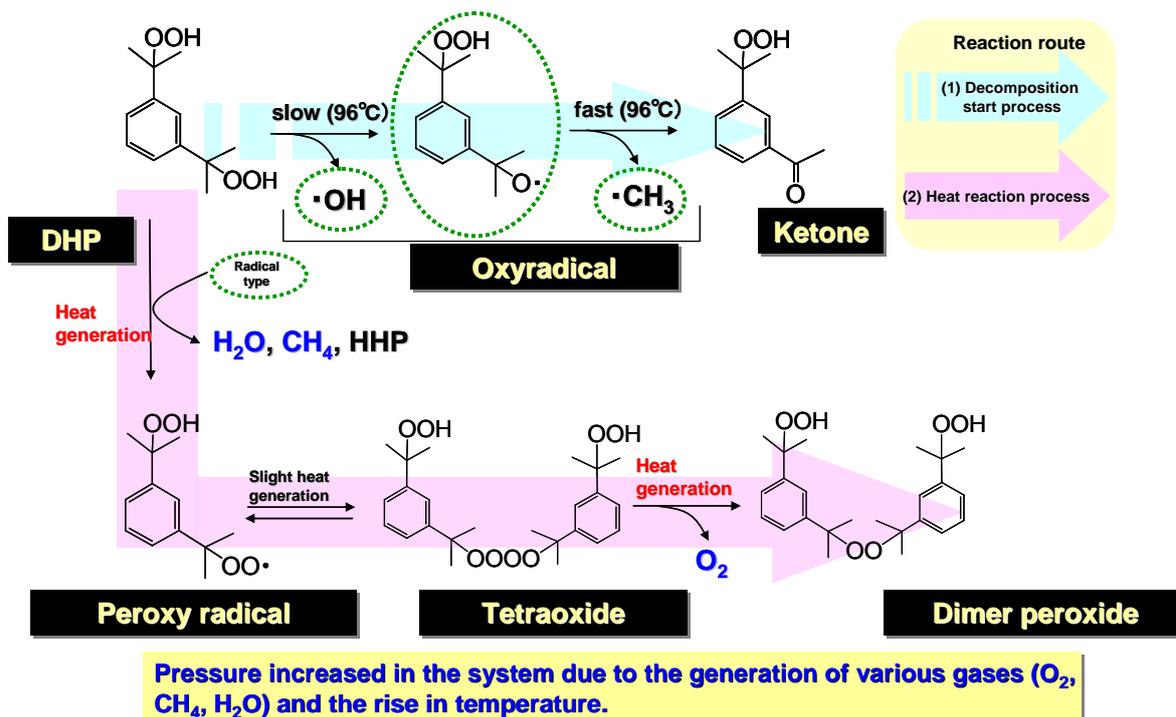
Figure 4-11 DHP decomposition reaction mechanism that can be estimated from computational chemistry

The decomposition reaction mechanism of DHP was estimated using a computational chemistry method. As shown in Figure 4-11, first there is the process when the DHP decomposition begins with the generation of radicals. Next, there is heating reaction process where the radicals and the DHP react to generate peroxy radicals and peroxide dimer. During this heating reaction process, gas is generated from the water, methane and oxygen. Through confirmation of the small test solution in a heat decomposition test, the volume of gas generated tended to increase as the temperature rose, and the composition of the gas was 40 to 60% methane. (Refer to Figure 4-12)

From this, it can be assumed that with the rise in temperature, the radical cleavage and the heating reaction of DHP, a main ingredient of HPO, were gradually accelerated and the amount of gas generated increased as the temperature rose, resulting in the rise in pressure.
